Combined X-ray Diagnostics of Heterogeneous Biological Material

Abstract— The problem of finding a suitable diagnostic procedure for the examination of structural components of buildings has been closely analyzed in recent years. In this connection, the major interest is currently directed towards wood as a type of heterogeneous material; the utilized diagnostic procedures are under constant development to enable broad industrial application in the future. Within the research presented in this study, a new diagnostic method based on X-ray imaging has been proposed and tested. The technique utilizes the reduction of imaging information into 2D/3D planar projection, and it allows us to image clearly the rate of material damage by displaying the weighted damage rate. Another method is based on acoustic identification of structural elements infested with wood-destroying insects.

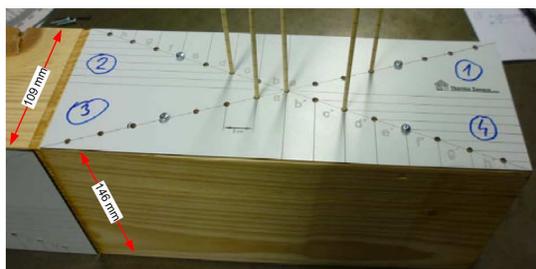
Figure 9: Instrumental box enabling the localization of an object inside a biological structure.

To facilitate the localization of a woodworm inside a biological structure, the scanning of the object must be performed from no less than two angles (ideally 90°). In this measurement, the pest is represented by a pin, mainly because metal is perfectly identifiable in an RTG image. While laboratory conditions enable us to measure the object in all three axes of the three-dimensional system, real measurements performed on a saved (treated) roof may not allow such configuration owing to the structure of examined buildings. For that reason, the measurement was realized for two angles, namely 0° and 90°. Through further processing, the obtained images helped us to gain insight into the location of the object (a pest larva) in a biological structure. A convenient setup (phantom) was manufactured to support the measurement, Fig. 9.

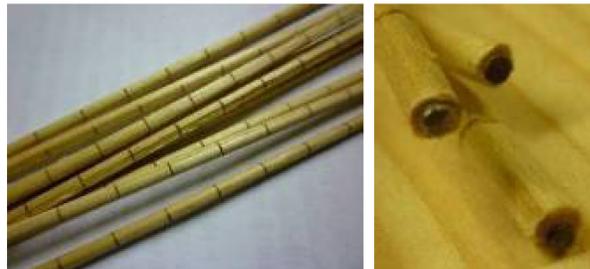
Figure 10: Tools for the localization of an object inside a biological structure.

during their insertion into the measuring setup. Before the real measurement, an 8 mm long metal phantom was pressed into one end of each gauge (Fig. 10) to improve the contrast of the resulting RTG image and simplify the detection of the pest.
